# Hunters Point Naval Shipyard BCT Meeting

Hunters Point Naval Shipyard BCT Meeting – June 27, 2013

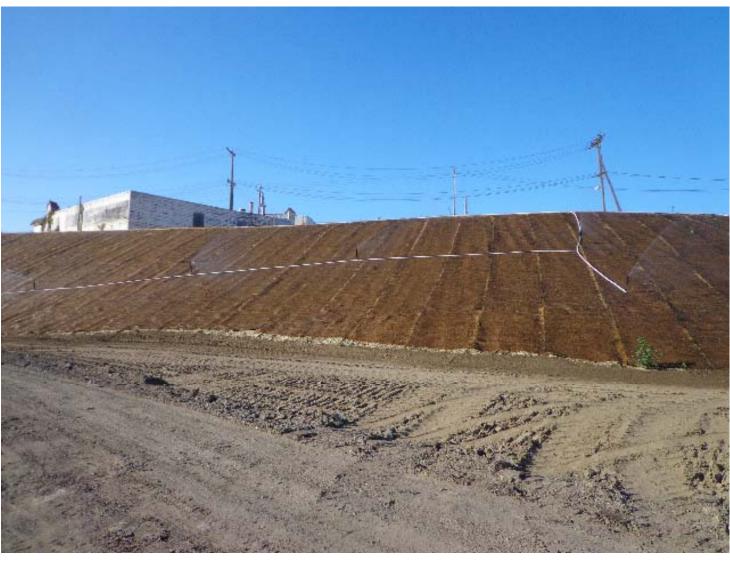
## **Operation of the Temporary Irrigation System**

- Completed installation of temporary irrigation system
- Began daily irrigation to start seed germination process

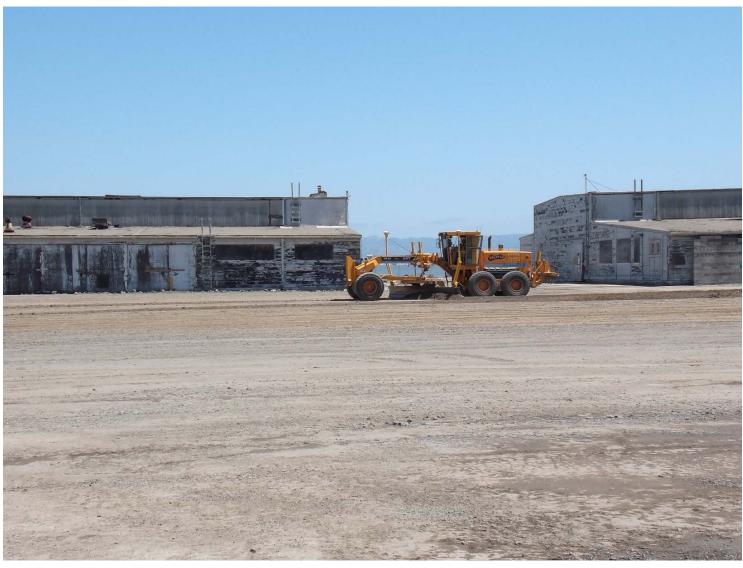
## Rough Grading of Subgrade with GPS-Guided Motorized Graders

- Continued rough grading using GPS-guided motorized graders (90% complete)
- Fine grading and paving scheduled to begin on July 8

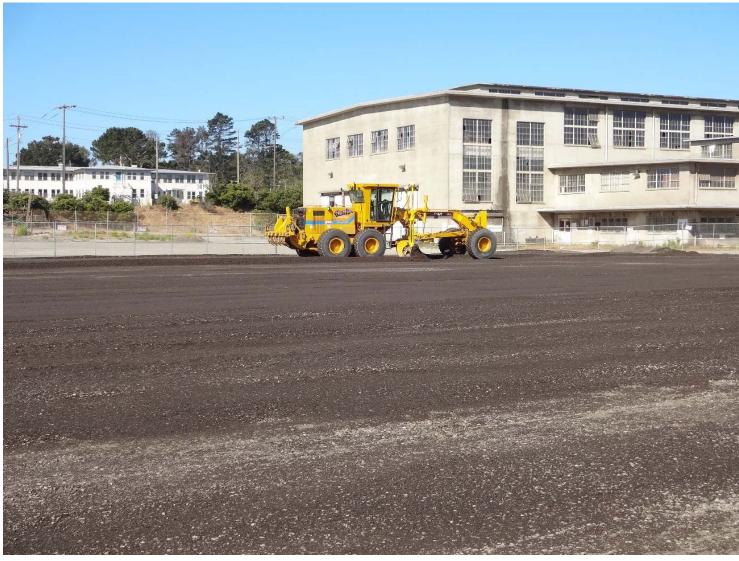
#### **Placement and Grading of Aggregate Base Course**

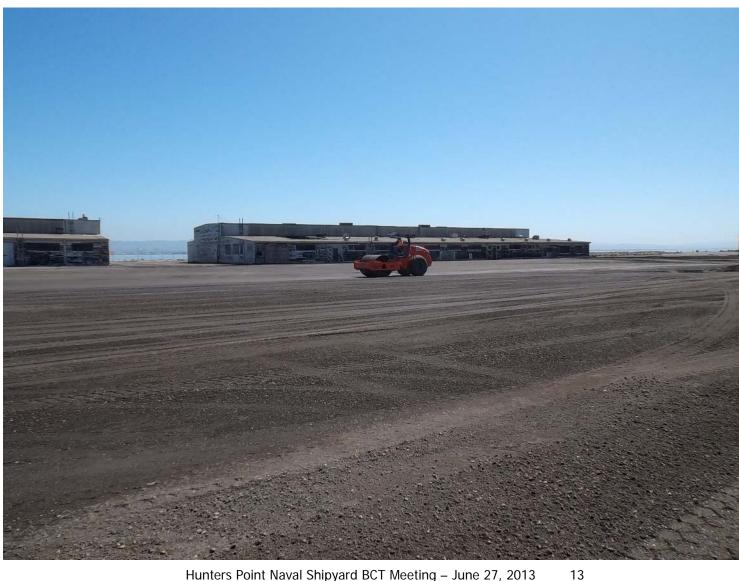
#### **Compaction of the Aggregate Base Course**

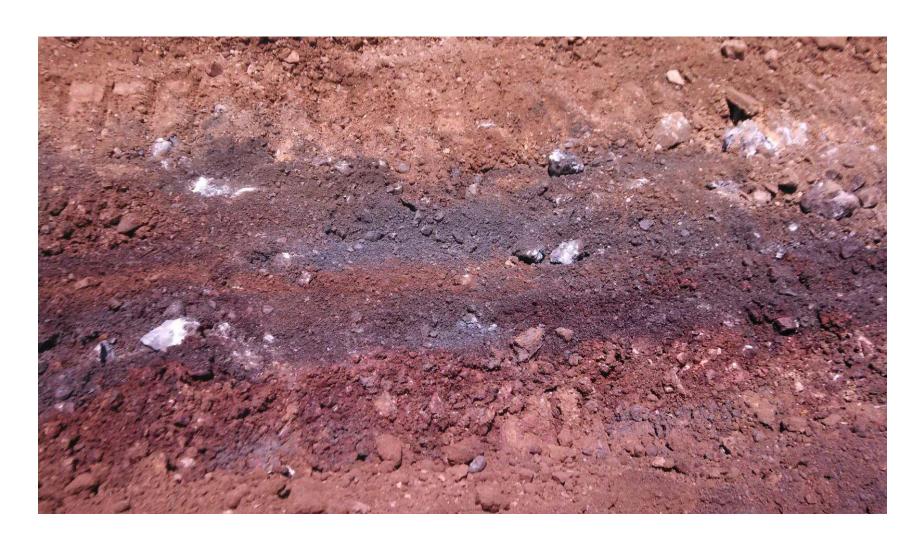
- On June 5, ERRG discovered petroleum contamination in soil while excavating swale in Parcel B (as part of rough grading for asphalt cover)
- Contamination was located within the footprint of the swale located between Building 130 and the Parcel B/C boundary (in the central portion of Parcel B)
- Contamination appeared to be shallow and limited to a 60' x 10' area within the footprint of the swale cut
- Notified RWQCB upon discovery
- The response action was implemented rapidly to prevent durable cover installation delays (next slide describes response actions)

#### **Visibly Impacted Soil Within Swale Excavation**

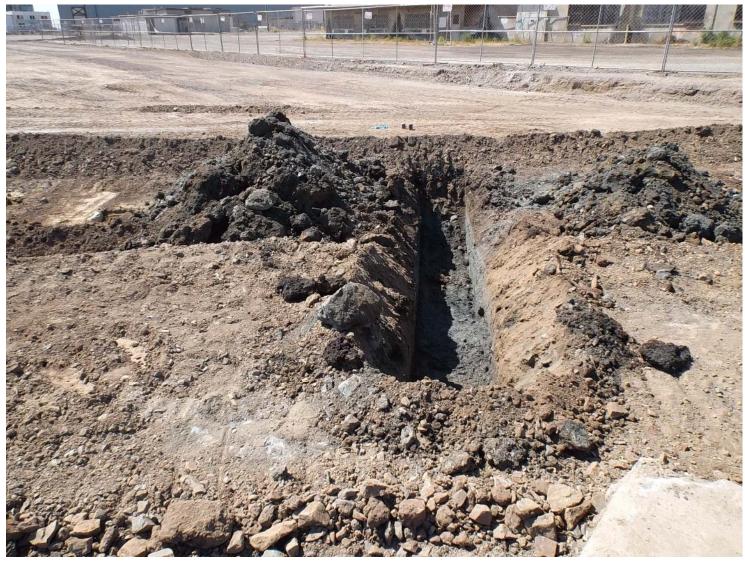
## Test Trench to Delineate Depth, Thickness, and Extent of TPH-Impacted Soil within Swale Excavation

- Response action included:
  - Exploratory trenching to assess depth, thickness, and extent of contamination (limited to 1-foot thick lens in surficial soil)
  - Collection of a sample of the most visually contaminated soil (concentrations of diesel range organics (DRO) above New Preliminary Petroleum Screening Criteria)
  - Excavation of all visibly contaminated soil and stockpiling for characterization and offsite disposal (approx. 100 cy)
  - Confirmation sampling along the bottom of the swale cut (1 sample per 20 feet) to confirm adequate removal of contamination
  - Future: TPH discovery and response action will be described and documented in the RACR

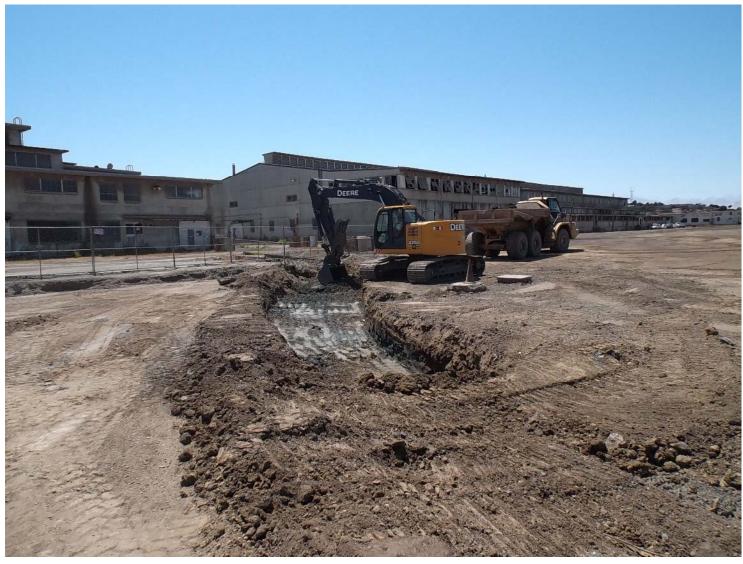
#### Removal of TPH-Impacted Soil from Swale
